# Death in the line of duty...

A Summary of a NIOSH fire fighter fatality investigation

## **Pumper Truck Rollover Claims the Life of a Volunteer Fire Fighter - Missouri**

## Fatality Assessment and Control Evaluation Investigative Report #F2000-33

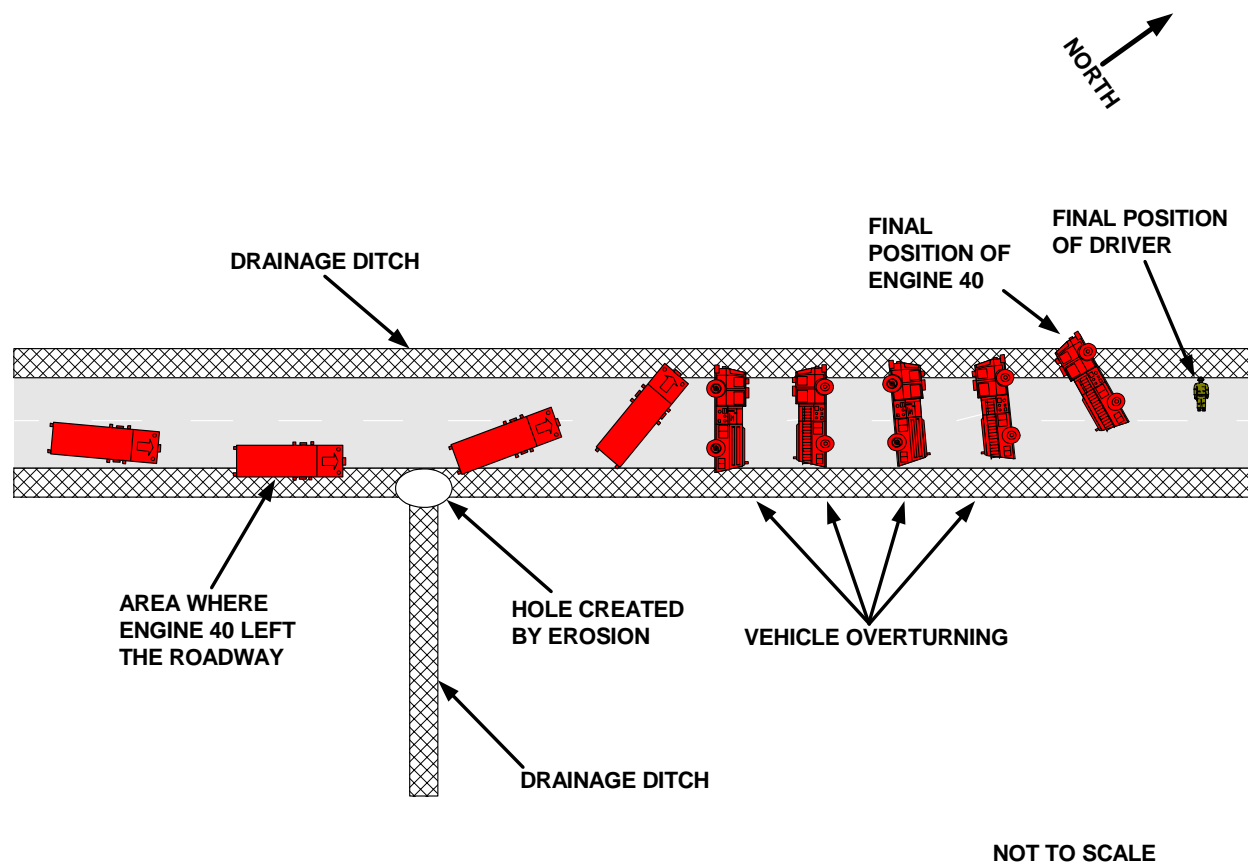
*Diagram. Aerial View of Incident Site*

counterclockwise, came back onto the roadway and overturned. The engine rolled approximately one and three-quarter revolutions as it continued to skid, traveling northbound (see Diagram). The victim was ejected from the engine and sustained fatal injuries as a result of the collision. The engine came to rest on its left side, facing west and blocking the southbound lane of the roadway. The cab area of the engine burst into flames as it sat at rest.

hole created by erosion at the end of a drainage culvert (see Diagram). *Note: The large hole was estimated to be 8 feet in depth and 15 feet in width.* The victim lost control of the engine when he overcorrected and applied his brakes in his attempt to steer the engine back to the roadway left (west) side. The engine rotated counterclockwise, and came back up onto the road and traveled across the roadway. The engine traveled across the road for approximately 18 feet before overturning. The engine rolled approximately one and three-quarter revolutions and slid as it continued northbound. The engine came to rest on the passenger side, partially off the roadway on the left (west) side of the roadway, blocking the southbound lane (see Photo #2). The victim was ejected from the engine, sustaining fatal injuries. *Note: It remains undetermined as to where the victim exited the engine. The victim was wearing ordinary street clothes. The engine was equipped with a shoulder and lap seat belt safety restraint system for the driver and passenger positions. The highway patrol's report indicated that the victim was not wearing his seat-belt safety restraint system at the time of the incident.* The cab area of the engine burst into flames as it sat at rest. The Captain, who was following the engine, stopped approximately 50 feet back from the engine and radioed to Central Dispatch to report the incident and request assistance. Between 1550 hours and 1553 hours, the following were dispatched to the incident scene: two mutual aid fire departments, and an ambulance. The Chief from the department in the incident heard the radio dispatch and responded from his residence in his department vehicle. The Assistant Chief was approximately 1 mile away from the incident scene and heard the radio traffic and responded. At approximately a half-mile away from the scene the Assistant Chief could see smoke coming from the roadway. Once on the scene he observed the Captain looking for the victim near the engine.

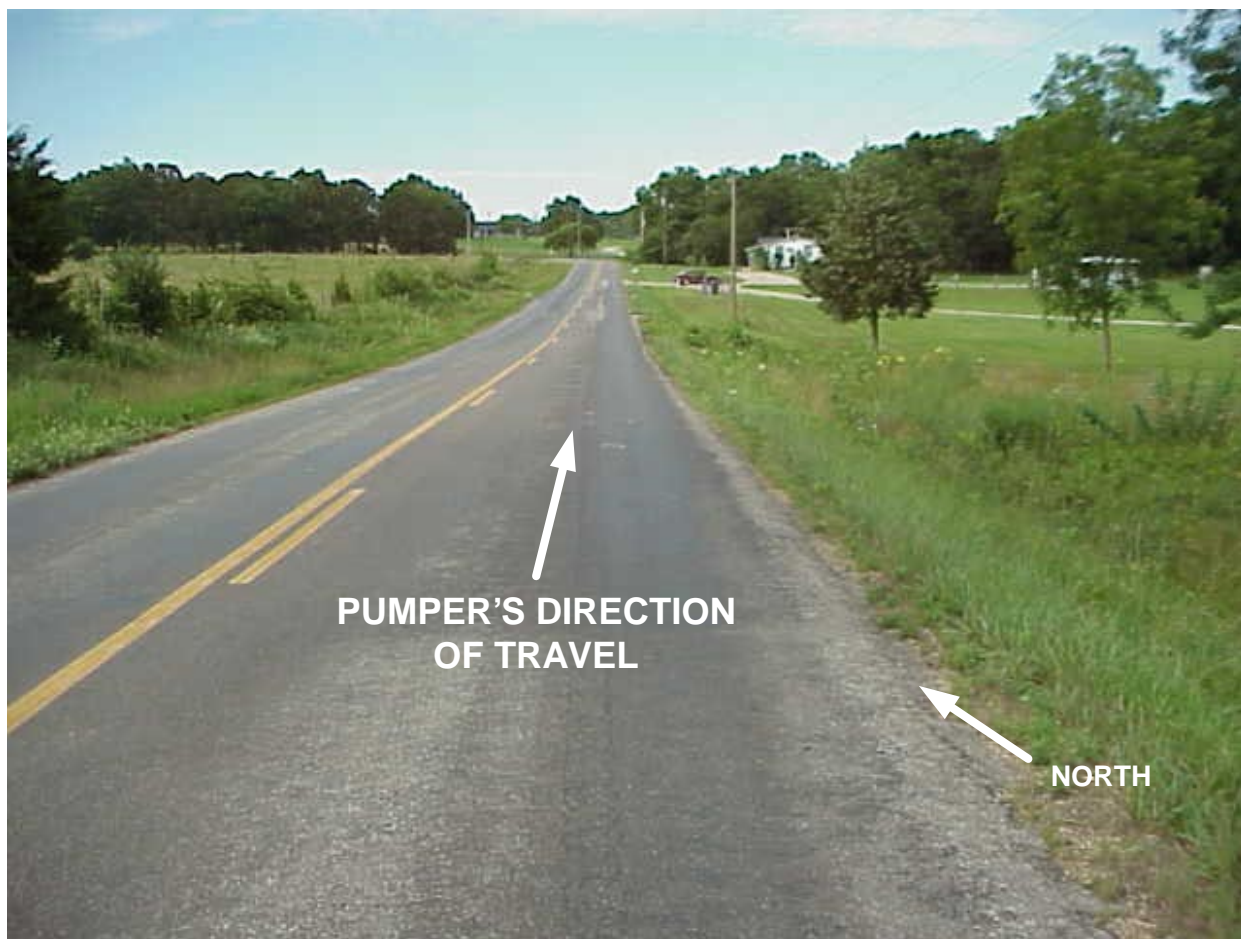
Discussion: Fire departments should ensure drivers of fire service vehicles are familiar with the potential hazards/conditions that exist on the roadways (e.g., insufficient shoulder) on which they may be traveling. In this incident, the speed of the engine when it left the roadway was estimated to be under the posted 55 mph speed limit, however, for unknown reasons the engine drifted off the roadway. The potential motor vehicle hazards that existed on the roadway of this incident included (1) the earthen embankment being soft, (2) no shoulders, and (3) a large hole that was created by erosion at the end of a drainage culvert.

***Photo 1.*** View of Road Traveling Northbound Where Pumper Truck Veered Off Road and Rolled Over

***Recommendation #1: Fire departments should ensure all drivers of fire department vehicles are responsible for the safe and prudent operation of the vehicle under all conditions.<sup>1</sup>***

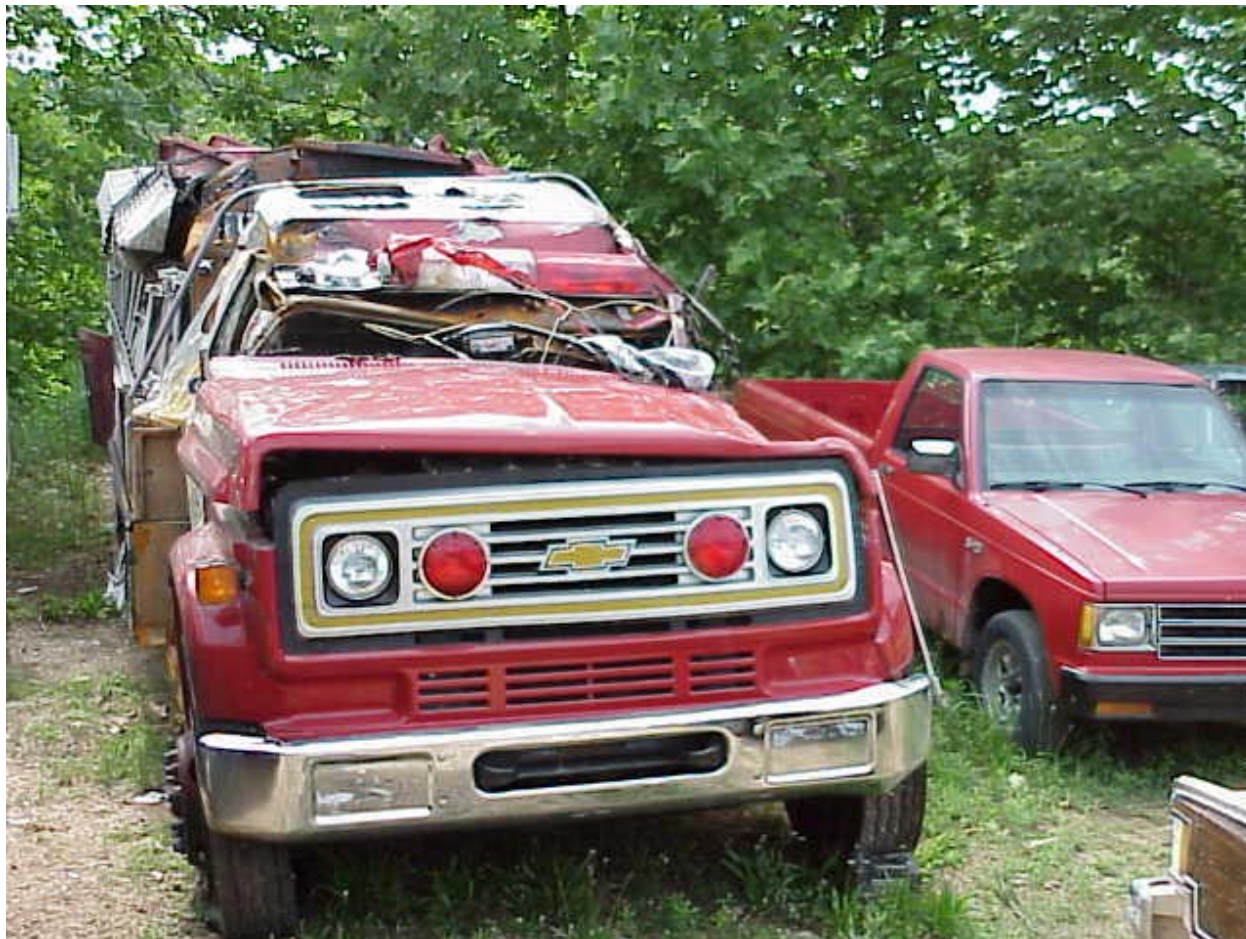
***Photo 3. Pumper Truck Involved in This Incident***
